**TIMBER
QUEENSLAND**
We build Queensland

Timber Queensland Limited

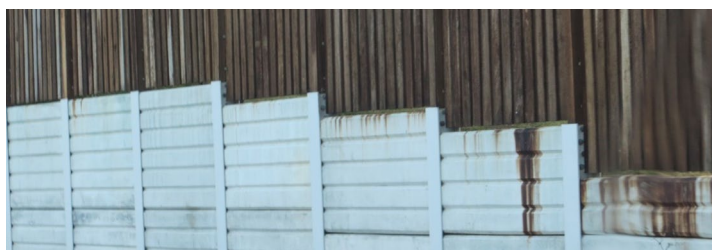
When unpainted or unsealed timber is used in situations where it is frequently wet by rain such as decking, cladding, fencing and framing, the water runoff may contain tannins which will cause brown stains on brick, concrete or painted surfaces.

Photograph 1 - Unpainted hardwood causing tannin stains on concrete

Preventative measures include providing some form of protection from the weather or sealing the timber surfaces with paint or other sealing compound. Quality paint systems will be more effective than stains. Refer Technical Data Sheet #2 Finishes for Exterior Timber.

Staining effects will be minimised by using seasoned timber or by careful selection of species (see Table 1). If painting or sealing is proposed this should be carried out before the timber members are fixed in place, ensuring that end grain, holes, notches and joint areas are properly sealed. Fasteners should also be hot dipped galvanized or stainless steel.

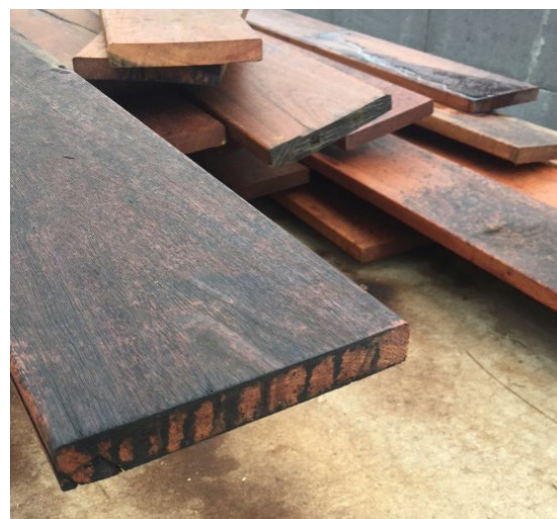
A recent job under construction that exhibited mould stains was with spotted gum decking that had developed extensive stains on the upper surfaces (see photograph 2). This decking had been coated on site using a 50/50 mix of linseed oil and turpentine. Linseed oil is a vegetable oil that is high in nutrients, so in the presence of moisture, air borne mould spores will start to grow and cause black stains, as occurred in this instance. Coating decking all round prior to laying is recommended for short term protection and appropriate products need to be used.

Photograph 2 - Mould stains on linseed oiled decking

Oxalic acid is a mild bleaching agent and should be used as a 2 percent solution in either hot distilled water or methylated spirits. The solution should be stored in a glass or earthenware container. Chemical contact with the skin should be avoided at all times. Rubber gloves and safety glasses should be used when applying the solution and a mask worn when sanding the treated surface.

The solution is easy to apply with a paint brush. Any excess should be wiped off after 15 minutes and the surface allowed to dry overnight. This process may need to be repeated several times. Once the desired result has been obtained, the surface may be neutralised with a 0.5 per cent borax solution if the acid is likely to affect gluing or finishing of the timber.

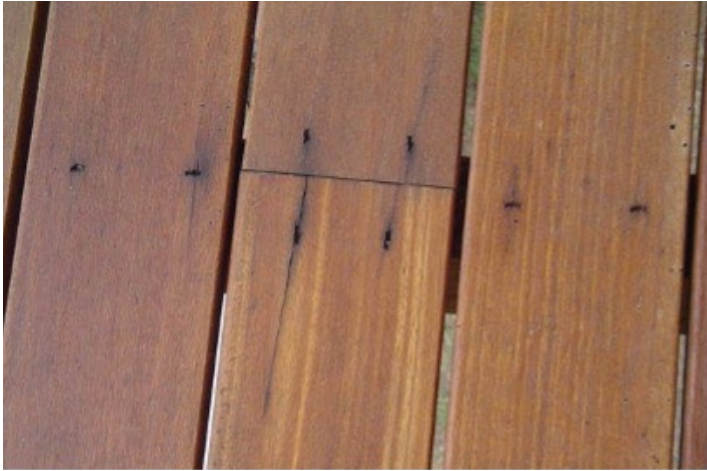
Wood which has a high tannin content is liable to be affected by iron staining when it comes into contact with steel. Iron stains are blue-black in colour and result from unseasoned or wet timber coming into contact with iron based materials such as tin cans, unprotected nails, saw blades, metal strapping, filings or some sandblasting compounds.

Photograph 3 - Iron staining due to ungalvanized nails (also nails are not appropriate type)

To prevent iron staining occurring in timber it is necessary either to use seasoned timber and to keep it dry, or to use hot dip galvanized fasteners and keep iron based metals away from the timber. Coating the timber with a water repellent product may minimise the incidence of iron staining.

If iron staining is the problem, household bleach could be tried before resorting to oxalic acid.
